**Flood Control Project Maintenance  
Levee Inspections**

## Maintenance Issue Types Only, Levee Inspection Report By Mile - Spring 2017

### Reclamation District No. 2085 Kasson

Waterway	Bank	Unit Miles	Inspection Start/End	Inspector
Unit No. 01 San Joaquin River	Left	5.29	04/20/2017 04/20/2017	Maksim Khashchuk

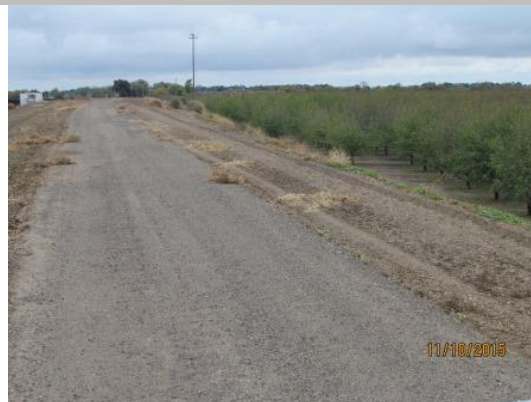
Photo 1 of 1 : SP\_2017\_RD2085\_113\_19\_20170407\_00010.jpg

LM Start	0.12	Rating **	A/W	Issue No.	19
LM End	0.47	Issue Type +	Ma	Location *	CR
Category	Earthen Levee			GPS Latitude/Longitude	
				Start	End
Item	Crown Surface / Depressions / Rutting			37.719052 °	37.723246 °
				-121.302928 °	-121.299492 °
DWR ID	DWR_RD2085_01_f_2015_19				
Comment Code					
C1 : Add appropriate material and re-grade the levee to bring the crown above the design elevation.					
Inspector Comment					
Disking on the levee shoulder. Make sure the water drains evenly to the slopes.

View of the disking on the levee crown shoulder.

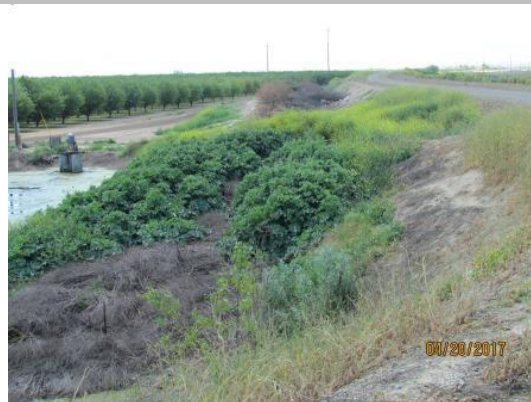
Photo 1 of 1 : SP\_2017\_RD2085\_113\_54\_20170421\_00069.jpg

LM Start	0.46	Rating **	U	Issue No.	54
LM End	0.48	Issue Type +	Ma	Location *	LS
Category	Earthen Levee			GPS Latitude/Longitude	
				Start	End
Item	Vegetation			37.723182 °	37.723383 °
				-121.299549 °	-121.299370 °
DWR ID	DWR_RD2085_01_s_2017_54				
Comment Code					
V1 : Control annual grass and weeds on the levee slopes and easements.					
Inspector Comment

View of the vegetation on the landside levee slope.

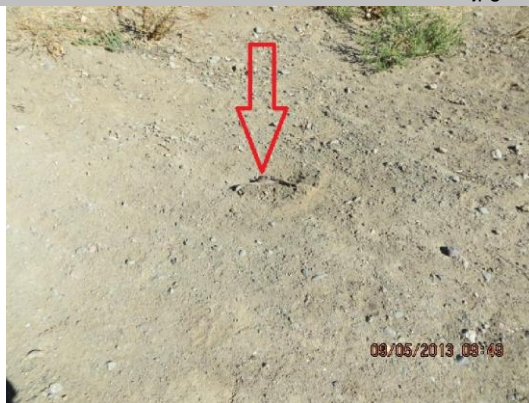
Photo 3 of 3 : UCIP\_SP\_2017\_47170\_62260.jpg

Item	DWR UCIP LMA Responsibility			37.723415 °		37.723415 °
				-121.298596 °		-121.298596 °
DWR ID						
Comment Code						
Inspector Comment						
FS_ID:47170						
DS_ID:20677						
EP_NO: N/A						
Repair Type: No Action Needed						
Crossing Status: Found						
UCIP Comments: Pipe has been removed by LMA.Previous:Pipe abandoned. Erosion around pipe on WS slope. Pipe severely corroded. Pier badly damaged.						
FIELD_STRUCT_DESC: *REMOVED* 14-inch steel stormdrain pipe through the levee 4.5 feet below crown. Pump on pile structure in ditch on the landward side. Siphon breaker in corrugated metal riser unit on the waterward shoulder. Originally included in the 1968 O&M manual. Pipe removed by LMA. Permit Application No. T2013179 submitted to CVFPB. Permit was not needed per CVFPB review.						
FS Date: 9/5/2013

Siphon breaker in 24-inch CMP riser on WS shoulder. Filled with soil.

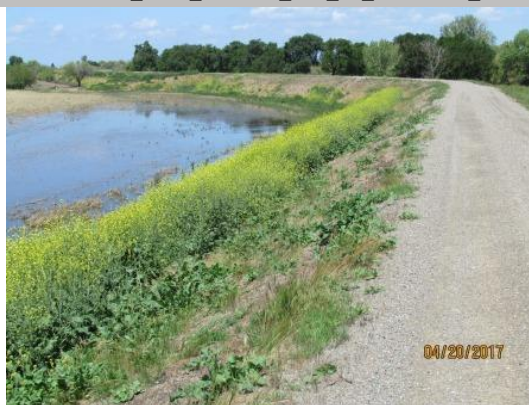
Photo 1 of 1 : SP\_2017\_RD2085\_113\_48\_20170421\_00068.jpg

LM Start	0.70	Rating **	M	Issue No.	48
LM End	1.09	Issue Type +	Ma	Location *	LS
Category	Earthen Levee			GPS Latitude/Longitude	
				Start	End
Item	Vegetation			37.721939 °	37.717553 °
				-121.296102 °	-121.291828 °
DWR ID	DWR_RD2085_01_s_2017_48				
Comment Code					
V1 : Control annual grass and weeds on the levee slopes and easements.					
Inspector Comment

View of the vegetation on the landside levee slope.

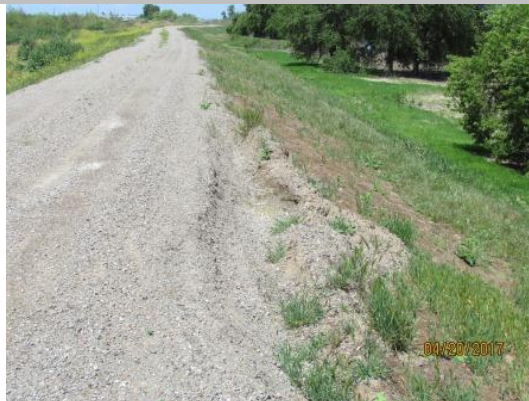
Photo 1 of 1 : SP\_2017\_RD2085\_113\_53\_20170421\_00070.jpg

LM Start	0.87	Rating **	M	Issue No.	53
LM End	0.87	Issue Type +	Ma	Location *	WS
Category	Earthen Levee			GPS Latitude/Longitude	
				Start	End
Item	Slope Stability			37.720142 °	37.720142 °
				-121.294027 °	-121.294027 °
DWR ID	DWR_RD2085_01_s_2017_53				
Comment Code					
S3 : Repair the levee slope damaged by vehicle traffic and prevent access where possible.					
Inspector Comment

View of the tire rut on the waterside levee shoulder.

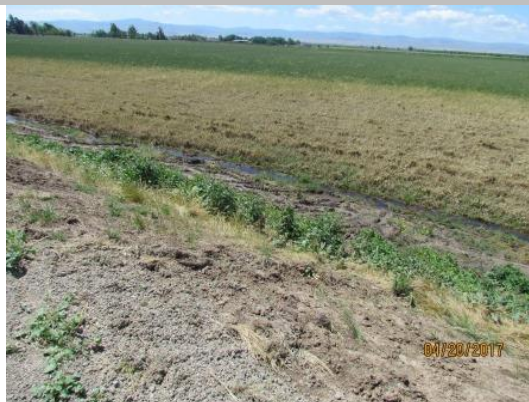
Photo 1 of 1 : SP\_2017\_RD2085\_113\_47\_20170421\_00067.jpg

LM Start	1.18	Rating **	M	Issue No.	47
LM End	1.18	Issue Type +	Ma	Location *	LS
Category	Earthen Levee			GPS Latitude/Longitude	
				Start	End
Item	Slope Stability			37.716216 °	37.716216 °
				-121.291387 °	-121.291387 °
DWR ID	DWR_RD2085_01_s_2017_47				
Comment Code					
S3 : Repair the levee slope damaged by vehicle traffic and prevent access where possible.					
Inspector Comment					
Vehicle ruts on the levee slope and toe.

View of the disturbed landside levee slope.

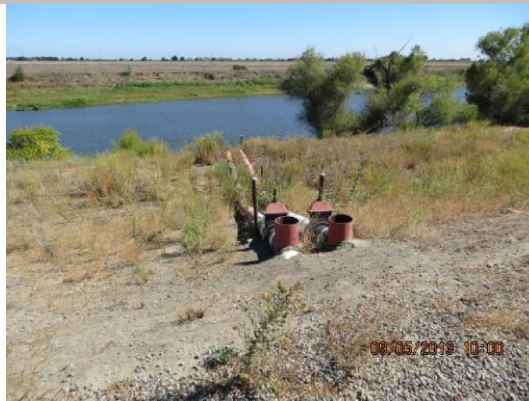
Photo 1 of 3 : UCIP\_SP\_2017\_19384\_32928.jpg

LM Start	1.35	Rating **	A/W	Issue No.	56
LM End	1.35	Issue Type +	Ma	Location *	LS
Category	Supplemental			GPS Latitude/Longitude	
				Start	End
Item	DWR UCIP LMA Responsibility			37.714409 °	37.714409 °
				-121.289479 °	-121.289479 °
DWR ID					
Comment Code					
Inspector Comment					
FS_ID:19384 DS_ID:20678 EP_NO: N/A Repair Type: No Action Needed Crossing Status: Found UCIP Comments: FIELD_STRUCT_DESC: 12-inch steel stormdrain pipe through the levee 3-feet below the crown. Pump mounted on pile structure in ditch on the landward side. Steel walkway with handrails to the pump structure. Gate valve and Siphon breaker in 12-inch steel riser unit on the waterward shoulder. Originally included in the 1968 O&M manual. (Permit No. 8189, 1972) FS Date: 9/5/2013

Pipe, siphon breaker, and gate valve on WS slope.

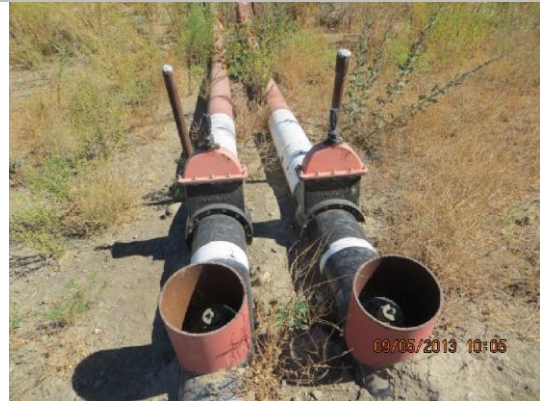
Photo 3 of 3 : UCIP\_SP\_2017\_19384\_32926.jpg

LM Start	1.35	Rating **	A/W	Issue No.	56 (cont)
LM End	1.35	Issue Type +	Ma	Location *	LS
Category	Supplemental			GPS Latitude/Longitude	
				Start	End
Item	DWR UCIP LMA Responsibility			37.714409 °	37.714409 °
				-121.289479 °	-121.289479 °
DWR ID					
Comment Code					
Inspector Comment					
FS_ID:19384 DS_ID:20678 EP_NO: N/A Repair Type: No Action Needed Crossing Status: Found UCIP Comments: FIELD_STRUCT_DESC: 12-inch steel stormdrain pipe through the levee 3-feet below the crown. Pump mounted on pile structure in ditch on the landward side. Steel walkway with handrails to the pump structure. Gate valve and Siphon breaker in 12-inch steel riser unit on the waterward shoulder. Originally included in the 1968 O&M manual. (Permit No. 8189, 1972) FS Date: 9/5/2013

Pipe, siphon breaker, and gate valve on WS slope.

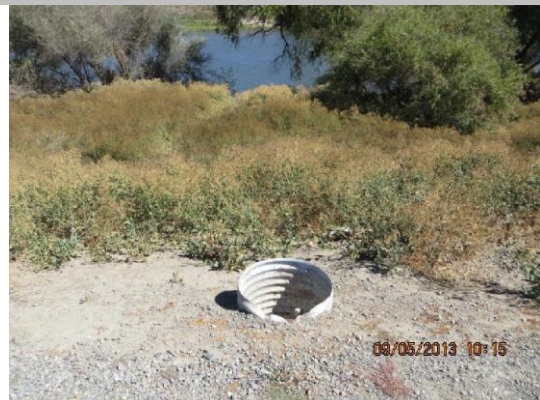
Photo 1 of 3 : UCIP\_SP\_2017\_41351\_62268.jpg

LM Start	1.41	Rating **	M	Issue No.	58
LM End	1.41	Issue Type +	Ma	Location *	LS
Category	Supplemental			GPS Latitude/Longitude	
				Start	End
Item	DWR UCIP LMA Responsibility			37.714049 °	37.714049 °
				-121.288426 °	-121.288426 °
DWR ID					
Comment Code					
Inspector Comment					
FS_ID:41351 DS_ID:20679 EP_NO: 3975 Repair Type: Non-Urgent Crossing Status: Found UCIP Comments: Pipe abandoned and should be done so properly. Large hole in ground over pipe on WS berm. Pipe rusted through on WS at river bank. No connection to pump on LS toe. FIELD_STRUCT_DESC: *ABANDONED* 10-inch steel stormdrain pipe through the levee 4-feet below the crown. Steel plate over pipe end at pump station on LS toe. Siphon breaker in 24-inch corrugated metal riser unit on the waterward shoulder (Permit No. 3975, 1962). Originally included in the 1968 O&M manual. FS Date: 9/5/2013

Siphon breaker in 24-inch CMP riser on WS shoulder.

Comment Code					
Inspector Comment					
FS_ID:41351					
DS_ID:20679					
EP_NO: 3975					
Repair Type: Non-Urgent					
Crossing Status: Found					
UCIP Comments: Pipe abandoned and should be done so properly.					
Large hole in ground over pipe on WS berm. Pipe rusted through on					
WS at river bank. No connection to pump on LS toe.					
FIELD_STRUCT_DESC: *ABANDONED* 10-inch steel stormdrain pipe					
through the levee 4-feet below the crown. Steel plate over pipe end at					
pump station on LS toe. Siphon breaker in 24-inch corrugated metal					
riser unit on the waterward shoulder (Permit No. 3975, 1962). Originally					
included in the 1968 O&M manual.					
FS Date: 9/5/2013

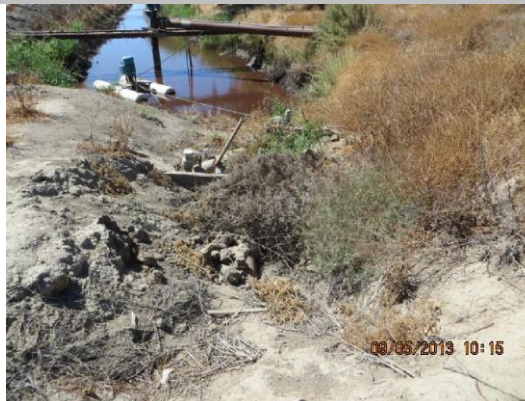
Photo 2 of 3 : UCIP\_SP\_2017\_41351\_62267.jpg

Pipe visible at bottom of ditch on LS toe.

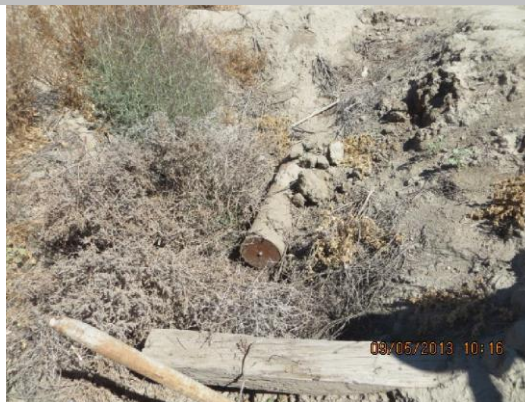
Photo 3 of 3 : UCIP\_SP\_2017\_41351\_62266.jpg

Pipe visible at bottom of ditch on LS toe.

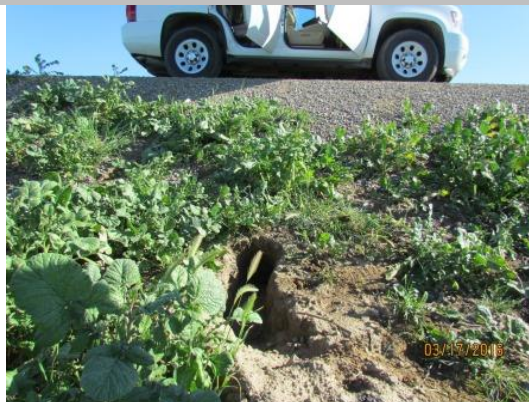
Photo 1 of 1 : SP\_2017\_RD2085\_113\_39\_20170407\_00022.jpg

View of the rodent burrows on the landside levee slope.

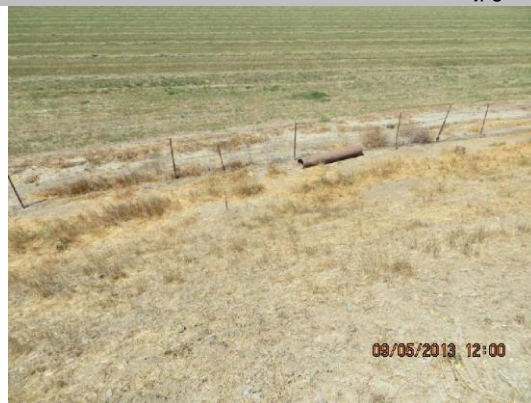
Photo 1 of 3 : UCIP\_SP\_2017\_19433\_32990.jpg

LM Start	3.30	Rating **	M	Issue No.	61
LM End	3.30	Issue Type +	Ma	Location *	LS
Category	Supplemental			GPS Latitude/Longitude	
				Start	End
Item	DWR UCIP LMA Responsibility			37.693618 °	37.693618 °
				-121.277639 °	-121.277639 °
DWR ID					
Comment Code					
Inspector Comment					
FS_ID:19433 DS_ID:20693 EP_NO: N/A Repair Type: Non-Urgent Crossing Status: Found UCIP Comments: Pipe appears abandoned and should be done so properly. FIELD_STRUCT_DESC: *ABANDONED* 10-inch steel stormdrain pipe through the levee 4.0-feet below the crown. T-post marks location of Pipe at LS toe. Steel plate welded over pipe on WS slope. Asbuilts available DWG 7-4-1685. Originally included in the 1968 O&M manual. FS Date: 9/5/2013

T-post marking pipe end on LS toe. 10-inch pipe debris on LS toe.

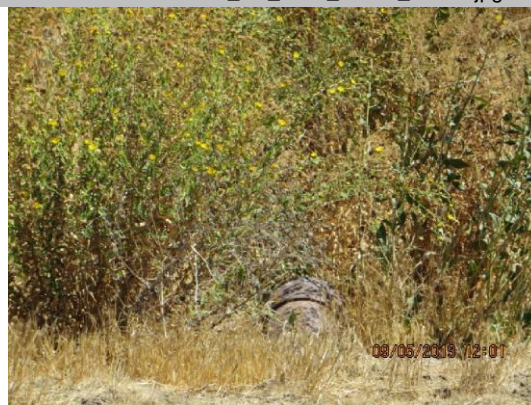
Photo 2 of 3 : UCIP\_SP\_2017\_19433\_32989.jpg

Pipe visible on WS slope.

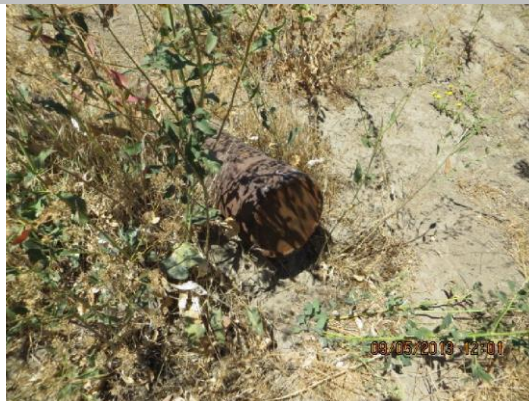
Photo 3 of 3 : UCIP\_SP\_2017\_19433\_32988.jpg

LM Start	3.30	Rating **	M	Issue No.	61 (cont)
LM End	3.30	Issue Type +	Ma	Location *	LS
Category	Supplemental			GPS Latitude/Longitude	
				Start	End
Item	DWR UCIP LMA Responsibility			37.693618 °	37.693618 °
				-121.277639 °	-121.277639 °
DWR ID					
Comment Code					
Inspector Comment					
FS_ID:19433 DS_ID:20693 EP_NO: N/A Repair Type: Non-Urgent Crossing Status: Found UCIP Comments: Pipe appears abandoned and should be done so properly. FIELD_STRUCT_DESC: *ABANDONED* 10-inch steel stormdrain pipe through the levee 4.0-feet below the crown. T-post marks location of Pipe at LS toe. Steel plate welded over pipe on WS slope. Asbuilts available DWG 7-4-1685. Originally included in the 1968 O&M manual. FS Date: 9/5/2013

Pipe visible on WS slope. Steel plate welded over end.

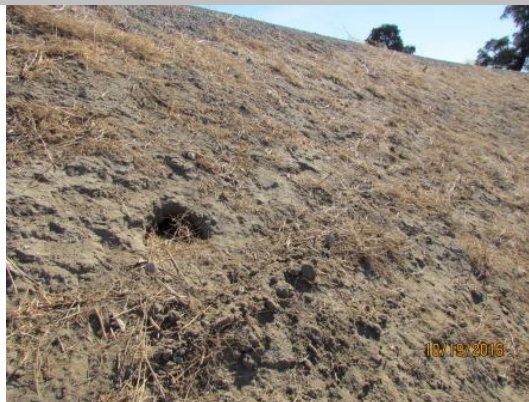
Photo 1 of 2 : SP\_2017\_RD2085\_113\_45\_20170407\_00023.jpg

View of the rodent burrows on the landside levee slope. Fall 2016

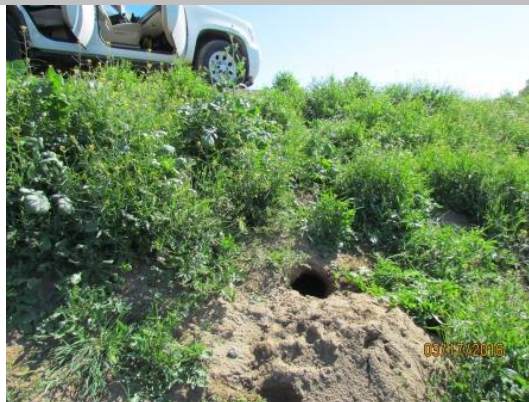
Photo 2 of 2 : SP\_2017\_RD2085\_113\_45\_20170407\_00024.jpg

View of the rodent burrows on the landside levee slope.

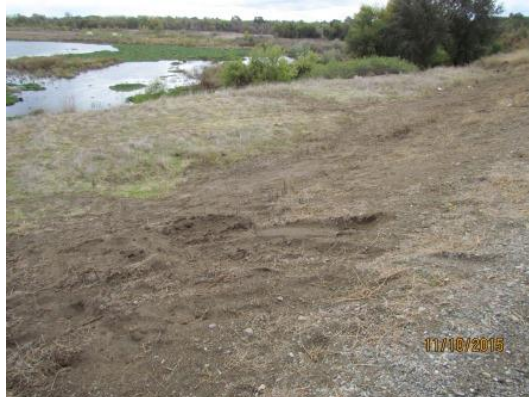
Photo 1 of 1 : SP\_2017\_RD2085\_113\_25\_20170407\_00012.jpg

LM Start	3.71	Rating **	A/W	Issue No.	25
LM End	3.71	Issue Type +	Ma	Location *	WS
Category	Earthen Levee			GPS Latitude/Longitude	
				Start	End
Item	Slope Stability			37.688216 °	37.688216 °
				-121.276603 °	-121.276603 °
DWR ID	DWR_RD2085_01_f_2015_25				
Comment Code					
S3 : Repair the levee slope damaged by vehicle traffic and prevent access where possible.					
Inspector Comment					
Control levee access to prevent damage to levee slopes by vehicle.

View of the waterside levee slope damaged by vehicle.

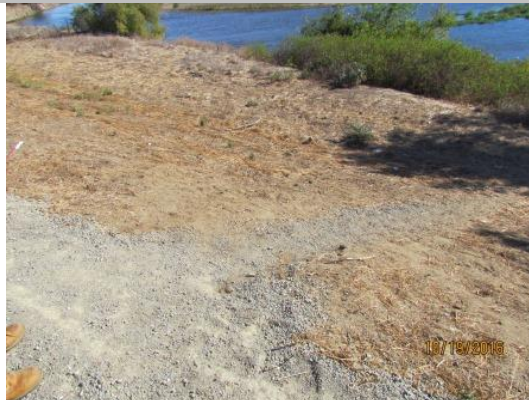
Photo 1 of 1 : SP\_2017\_RD2085\_113\_26\_20170407\_00013.jpg

LM Start	3.74	Rating **	A/W	Issue No.	26	
LM End	3.74	Issue Type +	Ma	Location *	WS	
Category	Earthen Levee			GPS Latitude/Longitude		
				Start		End
Item	Slope Stability			37.687841 °		37.687841 °
				-121.276678 °		-121.276678 °
DWR ID	DWR_RD2085_01_f_2015_26					
Comment Code						
S2 : Repair the levee slope damaged by foot traffic and prevent access where possible.						
Inspector Comment						
Area should be maintained to prevent further levee damage.

View of the foot path on the levee slope.

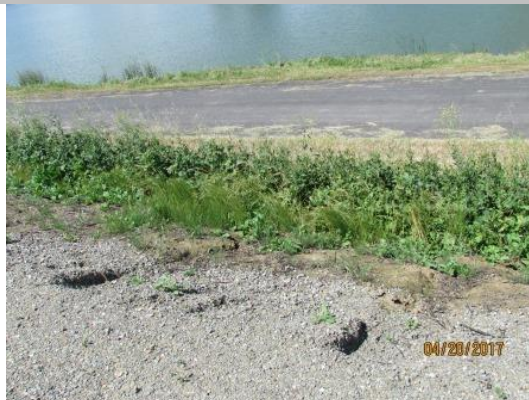
Photo 1 of 1 : SP\_2017\_RD2085\_113\_46\_20170421\_00065.jpg

LM Start	3.78	Rating **	M	Issue No.	46
LM End	3.78	Issue Type +	Ma	Location *	LS
Category	Earthen Levee			GPS Latitude/Longitude	
				Start	End
Item	Slope Stability			37.687253°	37.687253°
				-121.276780°	-121.276780°
DWR ID	DWR_RD2085_01_s_2016_46				
Comment Code					
S3 : Repair the levee slope damaged by vehicle traffic and prevent access where possible.					
Inspector Comment

View of the tire tracks on the levee slope.

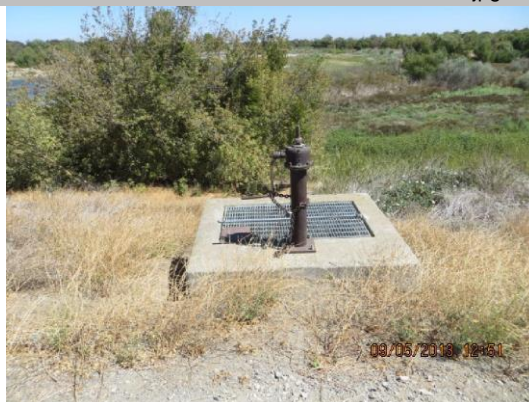
Photo 1 of 3 : UCIP\_SP\_2017\_19436\_32997.jpg

LM Start	3.80	Rating **	A/W	Issue No.	63
LM End	3.80	Issue Type +	Ma	Location *	LS
Category	Supplemental			GPS Latitude/Longitude	
				Start	End
Item	DWR UCIP LMA Responsibility			37.686976 °	37.686976 °
				-121.276838 °	-121.276838 °
DWR ID					
Comment Code					
Inspector Comment					
FS_ID:19436 DS_ID:20683 EP_NO: N/A Repair Type: No Action Needed Crossing Status: Found UCIP Comments: FIELD_STRUCT_DESC: 30-inch Reinforced concrete box culvert stormdrain through the levee 12.0 feet below the crown. Slide gate in concrete riser unit on the waterward slope. Concrete "U" headwalls on both ends. Flap gate on the waterward end. Two concrete cutoff walls. Originally included in the 1968 O&M manual. FS Date: 9/5/2013 9:49:55 AM

Slide gate in Concrete riser on WS shoulder.

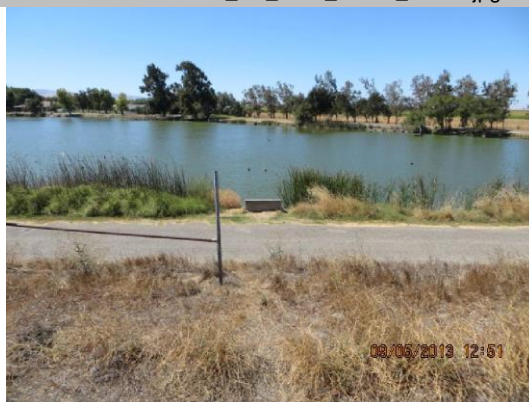
Photo 2 of 3 : UCIP\_SP\_2017\_19436\_32996.jpg

Concrete headwall off LS toe.

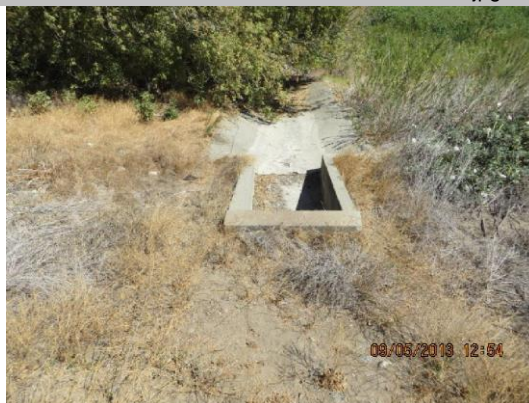
Photo 3 of 3 : UCIP\_SP\_2017\_19436\_32995.jpg

LM Start	3.80	Rating **	A/W	Issue No.	63 (cont)	
LM End	3.80	Issue Type +	Ma	Location *	LS	
Category	Supplemental			GPS Latitude/Longitude		
				Start	End	
Item	DWR UCIP LMA Responsibility			37.686976 °	37.686976 °	
				-121.276838 °	-121.276838 °	
DWR ID						
Comment Code						
Inspector Comment						
FS_ID:19436 DS_ID:20683 EP_NO: N/A Repair Type: No Action Needed Crossing Status: Found UCIP Comments: FIELD_STRUCT_DESC: 30-inch Reinforced concrete box culvert stormdrain through the levee 12.0 feet below the crown. Slide gate in concrete riser unit on the waterward slope. Concrete "U" headwalls on both ends. Flap gate on the waterward end. Two concrete cutoff walls. Originally included in the 1968 O&M manual. FS Date: 9/5/2013 9:49:55 AM

Concrete U-shaped headwall on WS slope.

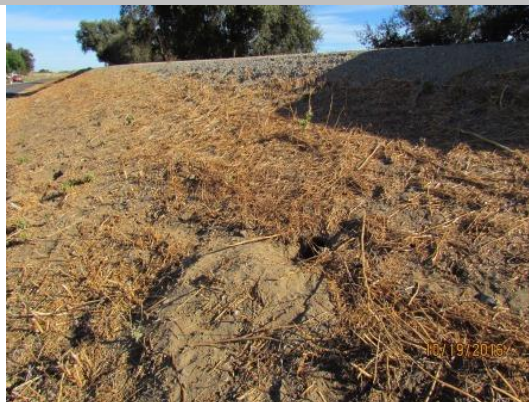
Photo 1 of 1 : SP\_2017\_RD2085\_113\_36\_20170407\_00021.jpg

LM Start	3.86	Rating **	M	Issue No.	36
LM End	3.91	Issue Type +	Ma	Location *	LS
Category	Earthen Levee			GPS Latitude/Longitude	
				Start	End
Item	Animal Control			37.686059 °	37.685340 °
				-121.276745 °	-121.276594 °
DWR ID	DWR_RD2085_01_f_2016_36				
Comment Code					
A3 : No rodents visible, but rodent burrows visible; need to backfill and compact or grout burrows.					
Inspector Comment

View of the rodent holes on the levee slope.

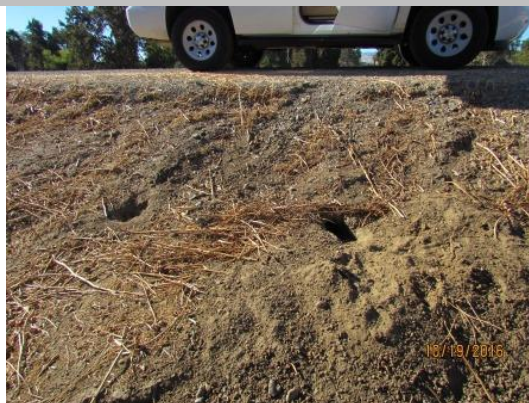
Photo 1 of 1 : SP\_2017\_RD2085\_113\_34\_20170407\_00020.jpg

View of the rodent holes on the levee slope.

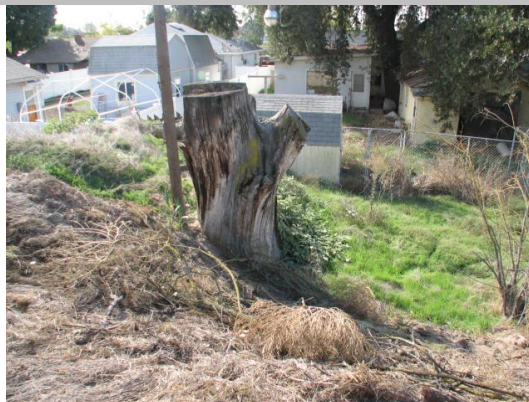
Photo 1 of 1 : SP\_2017\_RD2085\_113\_32\_20170407\_00017.jpg

LM Start	4.46	Rating **	N	Issue No.	32
LM End	4.46	Issue Type +	Ma	Location *	LS
Category	Earthen Levee			GPS Latitude/Longitude	
				Start	End
Item	Trim / Thin Trees			37.681605 °	37.681605 °
				-121.268882 °	-121.268882 °
DWR ID	DWR_RD2085_01_s_2012_32				
Comment Code					
T5 : Tree stumps.					
Inspector Comment

11/03/2011 Large stump on landside slope.

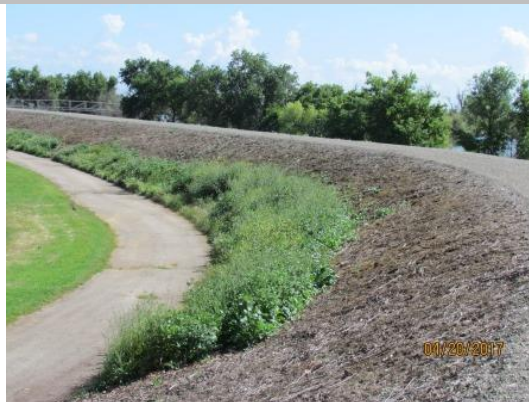
Photo 1 of 1 : SP\_2017\_RD2085\_113\_40\_20170421\_00063.jpg

LM Start	4.63	Rating **	M	Issue No.	40
LM End	4.88	Issue Type +	Ma	Location *	LS
Category	Earthen Levee			GPS Latitude/Longitude	
				Start	End
Item	Vegetation			37.680963 °	37.678389 °
				-121.265844 °	-121.266341 °
DWR ID	DWR_RD2085_01_s_2017_40				
Comment Code					
V1 : Control annual grass and weeds on the levee slopes and easements.					
Inspector Comment

View of the vegetation on the landside levee slope.

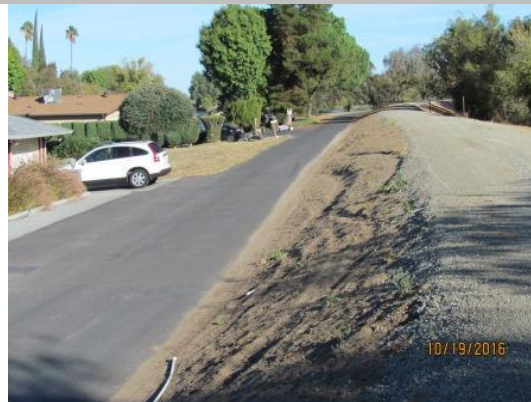
Photo 1 of 1 : SP\_2017\_RD2085\_113\_52\_20170407\_00026.jpg

LM Start	5.20	Rating **	M	Issue No.	52
LM End	5.20	Issue Type +	Ma	Location *	LS
Category	Earthen Levee			GPS Latitude/Longitude	
				Start	End
Item	Slope Stability			37.675620 °	37.675620 °
				-121.269359 °	-121.269359 °
DWR ID	DWR_RD2085_01_s_2016_52				
Comment Code					
S3 : Repair the levee slope damaged by vehicle traffic and prevent access where possible.					
Inspector Comment

View of the tire tracks on the levee slope.

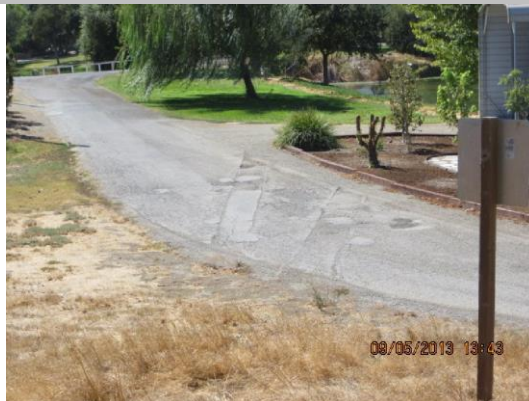
Photo 1 of 3 : UCIP\_SP\_2017\_23060\_39184.jpg

LM Start	5.22	Rating **	A/W	Issue No.	65
LM End	5.22	Issue Type +	Ma	Location *	LS
Category	Supplemental			GPS Latitude/Longitude	
				Start	End
Item	DWR UCIP LMA Responsibility			37.675271 °	37.675271 °
				-121.269281 °	-121.269281 °
DWR ID					
Comment Code					
Inspector Comment					
FS_ID:23060					
DS_ID:20686					
EP_NO: N/A					
Repair Type: No Action Needed					
Crossing Status: Found					
UCIP Comments:					
FIELD_STRUCT_DESC: 30-inch reinforced concrete stormdrain pipe					
through the levee 10.0 feet below the crown. Concrete "U" shaped					
headwall on the waterward end. Two corrugated metal cutoff walls. Flap					
gate on the waterward end. Originally included in the 1968 O&M					
manual.					
FS Date: 9/5/2013

Cuts in pavement off LS toe good indicator of pipe location.

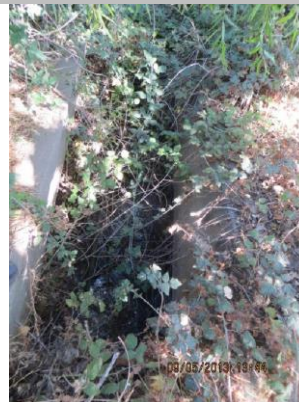
Photo 2 of 3 : UCIP\_SP\_2017\_23060\_39183.jpg

Concrete U-shaped headwall visible on WS toe.

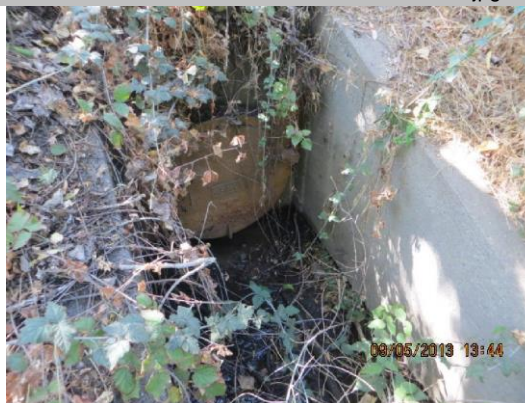
Photo 3 of 3 : UCIP\_SP\_2017\_23060\_39182.jpg

LM Start	5.22	Rating **	A/W	Issue No.	65 (cont)	
LM End	5.22	Issue Type +	Ma	Location *	LS	
Category	Supplemental			GPS Latitude/Longitude		
				Start	End	
Item	DWR UCIP LMA Responsibility			37.675271 °	37.675271 °	
				-121.269281 °	-121.269281 °	
DWR ID						
Comment Code						
Inspector Comment						
FS_ID:23060						
DS_ID:20686						
EP_NO: N/A						
Repair Type: No Action Needed						
Crossing Status: Found						
UCIP Comments:						
FIELD_STRUCT_DESC: 30-inch reinforced concrete stormdrain pipe						
through the levee 10.0 feet below the crown. Concrete "U" shaped						
headwall on the waterward end. Two corrugated metal cutoff walls. Flap						
gate on the waterward end. Originally included in the 1968 O&M						
manual.						
FS Date: 9/5/2013

Concrete U-shaped headwall and flapgate visible on WS toe.

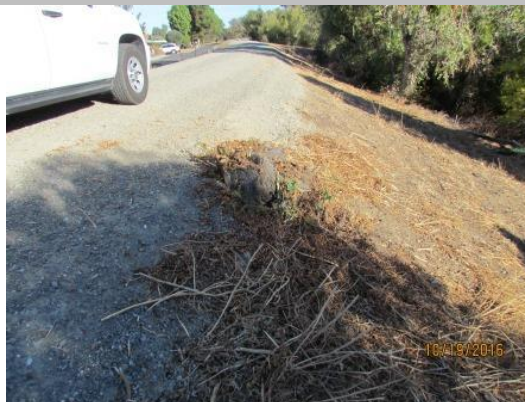
Photo 1 of 1 : SP\_2017\_RD2085\_113\_29\_20170407\_00016.jpg

LM Start	5.24	Rating **	N	Issue No.	29
LM End	5.24	Issue Type +	Ma	Location *	WS
Category	Earthen Levee			GPS Latitude/Longitude	
				Start	End
Item	Trim / Thin Trees			37.675099 °	37.675099 °
				-121.269264 °	-121.269264 °
DWR ID	DWR_RD2085_01_f_2015_29				
Comment Code					
T5 : Tree stumps.					
Inspector Comment

View of the tree stump.

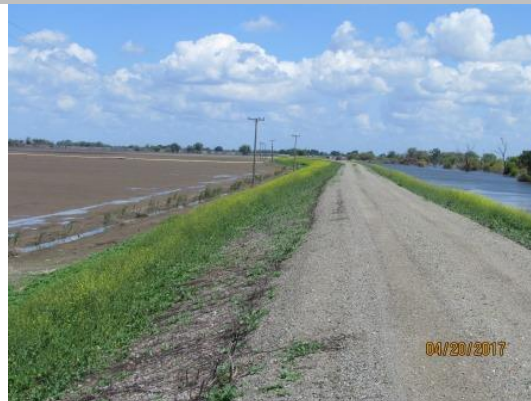
Photo 1 of 1 : SP\_2017\_RD2085\_114\_1\_20170421\_00001.jpg

View of the vegetation on the levee slope.

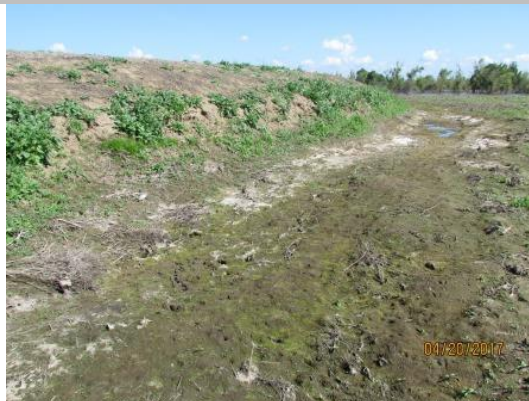
Photo 1 of 3 : SP\_2017\_RD2085\_115\_1\_20170421\_00004.jpg

LM Start	0.21	Rating **	U	Issue No.	1
LM End	0.23	Issue Type +	Ma	Location *	WS
Category	Earthen Levee			GPS Latitude/Longitude	
				Start	End
Item	Erosion / Bank Caving			37.682798 °	37.683052 °
				-121.262059 °	-121.261851 °
DWR ID	DWR_RD2085_03_s_2014_1				
Comment Code					
E2 : Schedule repair of erosion site prior to the next inspection.					
Inspector Comment					
Erosion of the waterside levee slope has been observed. The erosion is about 3 feet tall vertical from the slope to the base of projected levee toe.

View of the erosion at the waterside levee toe. Spring 2017.

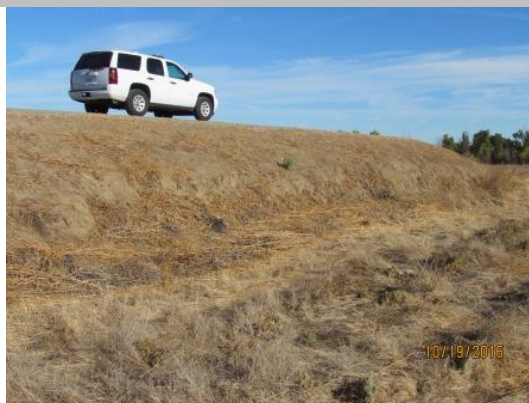
Photo 2 of 3 : SP\_2017\_RD2085\_115\_1\_20170407\_00001.jpg

View of the erosion at the waterside levee toe. Fall 2016.
